236-00: Case Narrative

Case Vehicle (A): 1998 Dodge	Vehicle (B): 1998 Pontiac	Vehicle (C): 1998 Ford
Type: Durango, 4-door 4x4 SUV	Type: Grand Prix, 2-door coupe	Type: Taurus, 4-door sedan
Driver: 25-year-old female	Driver: 17-year-old female	Driver: 34-year-old female
CDC: 12-FDEW-3, 06-BREE-1	CDC: 12-FYEW-3	CDC: 99-0000-00

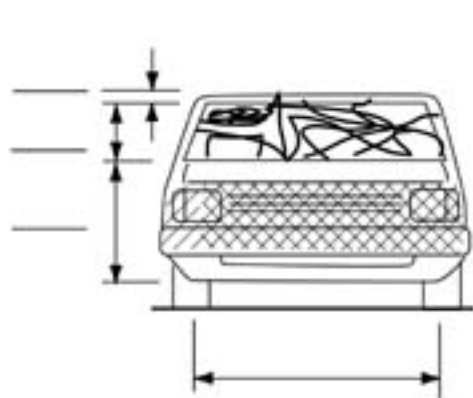
**Direct damage
length = 128 cm
Max crush = 74 cm**

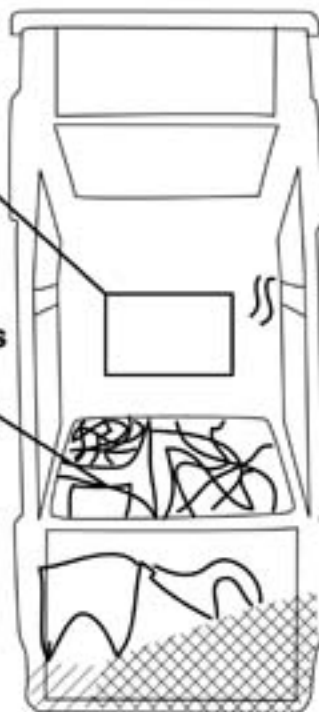
Wheel displaced
and restricted

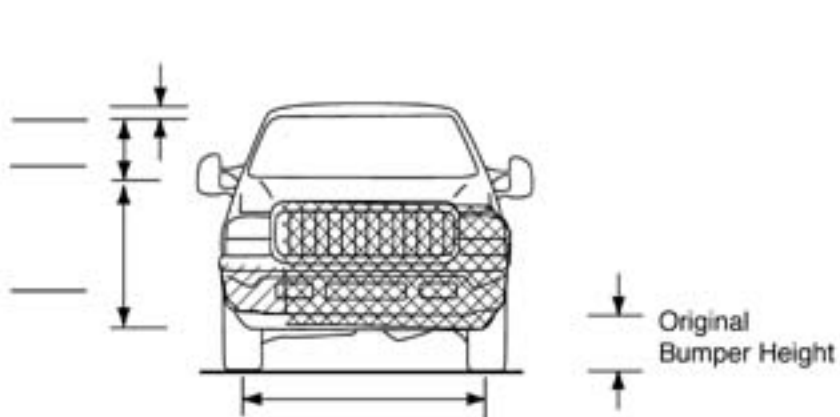
Direct damage length = 136 cm
Max crush = 65 cm
